Manhole Inspection Summary

Manhole # S17II_033MH

Insp Date: **6/8/07 10:04 AM**

Location Address: **1651 RUXTON-BENTALOU**

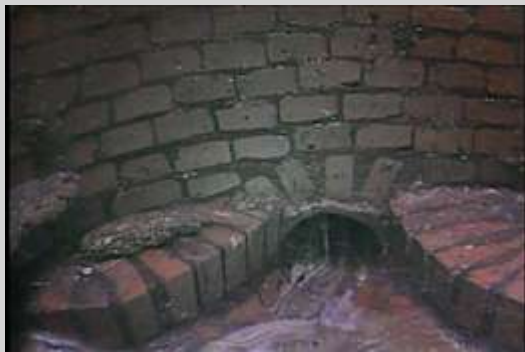
12 O'Clock Outflow

8 in. Circular Gravity Sewer
Pipe Out @ 12 O'Clock

Pipe Height: **7.2** (in.) Rod and Bar (Angled)
Pipe Material: **Clay** ☐ Pipe Lined
Invert Depth: **9.89** (ft.) Flow Characteristics: **Slow**
Deposits: ☒ None ☐ Mud ☐ Sludge ☐ Debris ☐ Grease
Silt Depth: (in.) Deposits Extent:
Infiltration: **None** Pipe Seal Cond: **Sound**

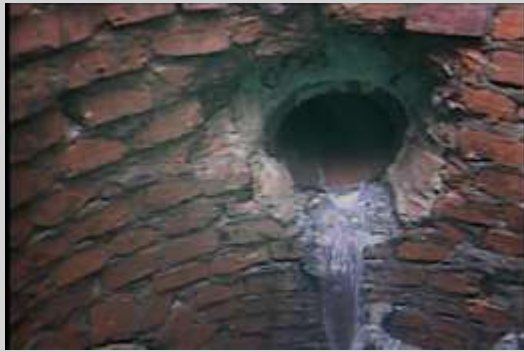
5 O'Clock Inflow

Pipe In @ 5 O'Clock

Pipe Height: **7.2** (in.) Rod and Bar (Angled)

Infiltration: **None** Pipe Seal Cond: **Sound**

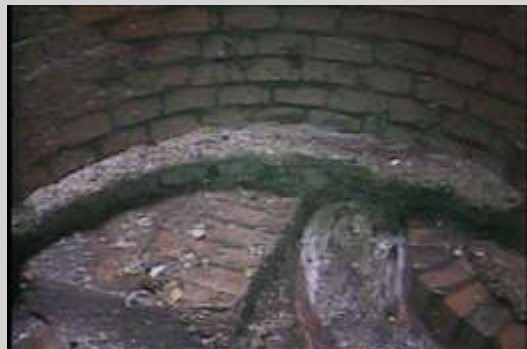
9 O'Clock Inflow

Pipe In @ 9 O'Clock

Pipe Height: **8.4** (in.) Rod and Bar (Angled)

Infiltration: **None** Pipe Seal Cond: **Sound**
